Maryland Historical Trust Determination of Eligibility Form

Property Name: Bridge No. D-028
Address: Backlanding Road over Hunting Creek
City: Preston **Zip Code:** _____
USGS Quadrangle(s): Preston
Property Owner: Dorchester County Department of Public Works
Tax Map Parcel Number(s): _____
Project: Replacement of Bridge No. D-028
Agency Prepared By: MHT
Preparer's Name: Tim Tamburrino
Documentation Is Presented In: MIHP Form D-709 completed during the Historic Bridge Inventory in 1995
Preparer's Eligibility Recommendation: _____ **Eligibility Recommended** ☒ **Eligibility Not Recommended**
Criteria: ☐ A ☐ B ☐ C ☐ D **Considerations:** ☐ A ☐ B ☐ C ☐ D ☐ E ☐ F ☐ G
Complete if the property is a contributing or non-contributing resource to a NR district/property:
Name of the District/Property: _____
Inventory Number: _____ **Eligible:** ☐ Yes ☐ No **Listed:** ☐ Yes ☐ No
Site Visit by MHT Staff: ☐ Yes ☐ No **Name:** _____ **Date:** _____

MHT No. D-709

Bridge Name Backlanding Road over Hunting Creek

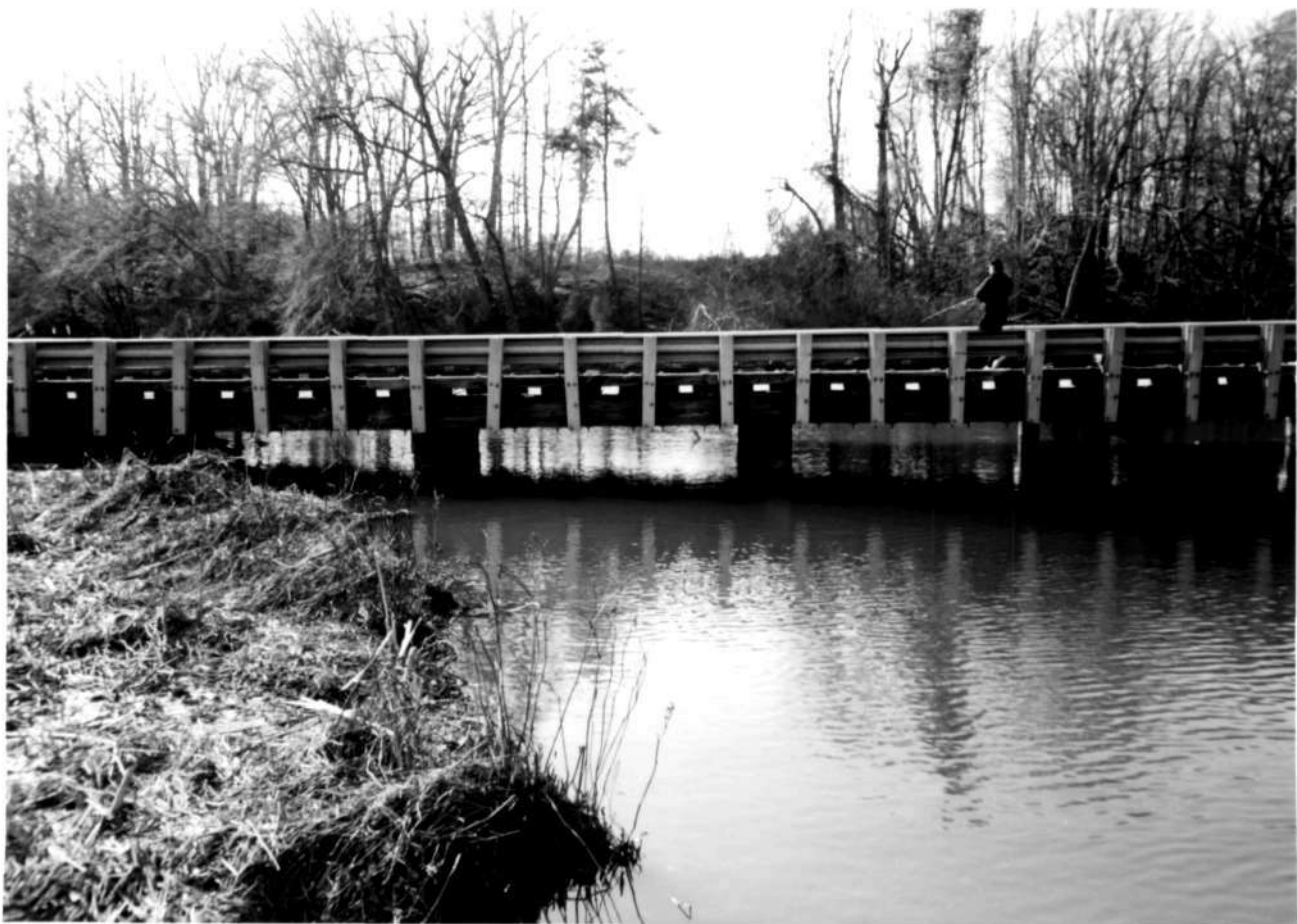
- 1 D-709
- 2 Back Landing over Hunting Creek
- 3 Dorchester County, MD
- 4 3/98
- 5 Marris German, WMA
- 6 MD SHPO
- 7 Elevation looking west, south half
- 8 1 of 4

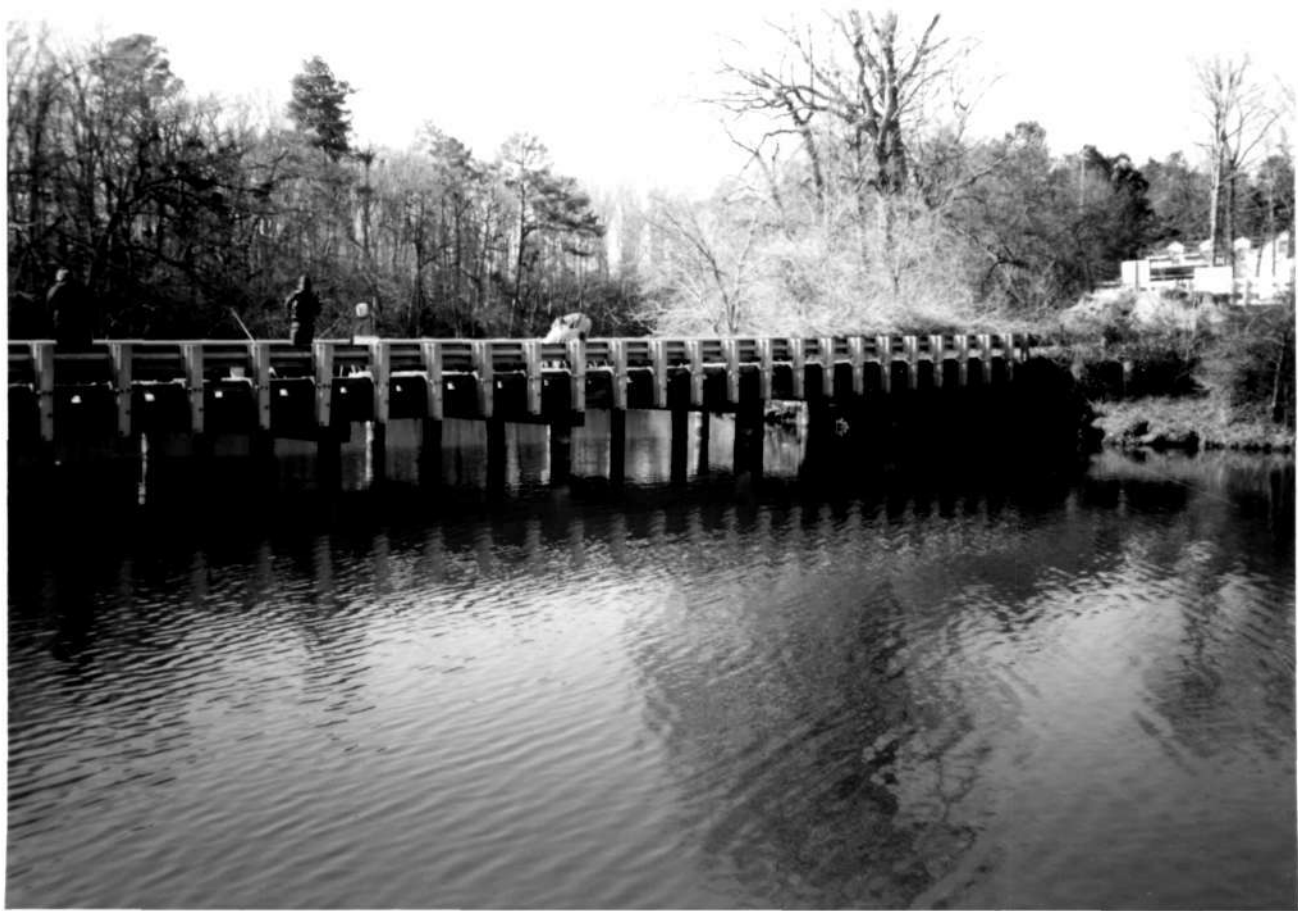
8 2 of 4

7 Elevation looking West, north half

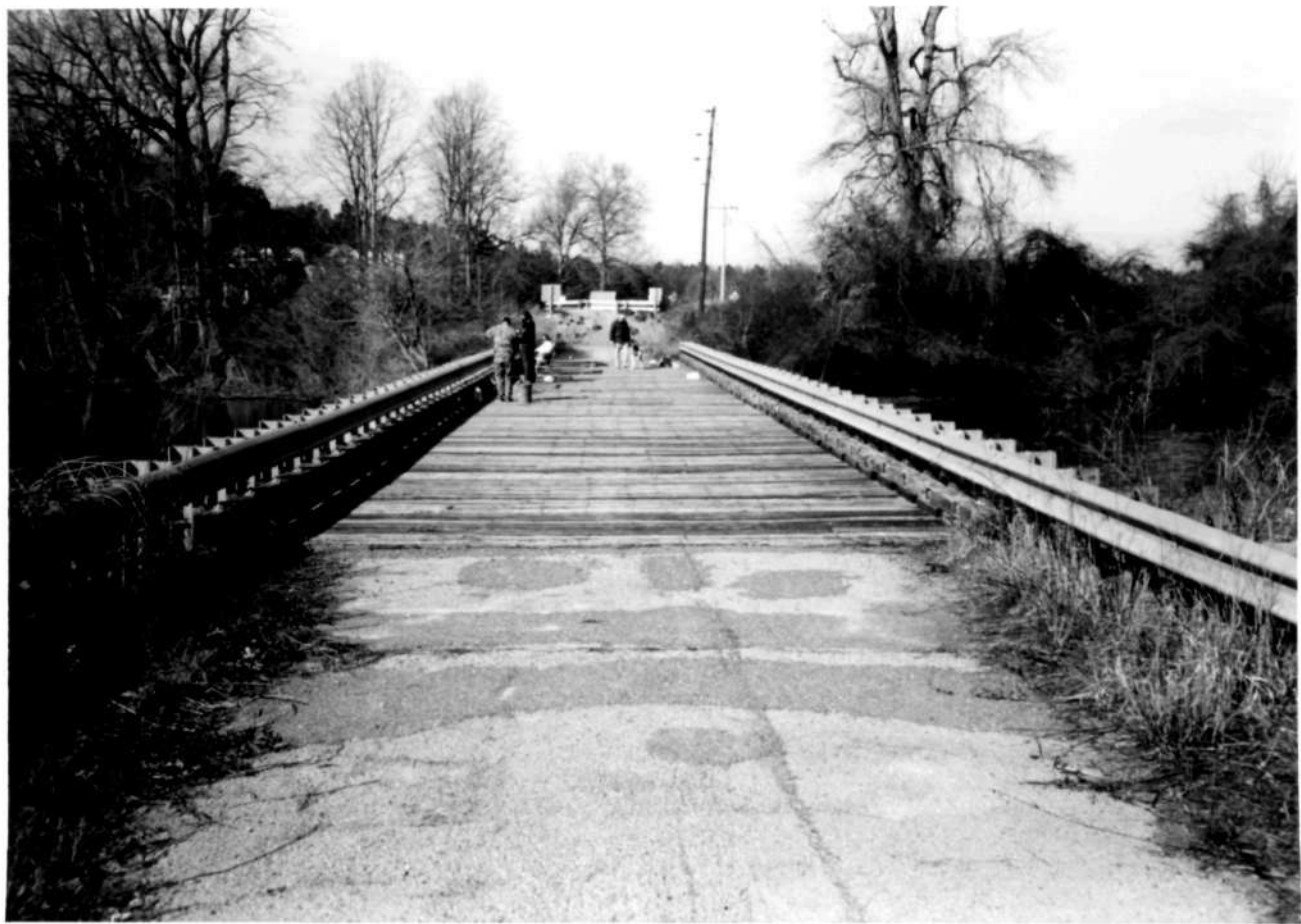
8 3 of 4

7 Looking North,

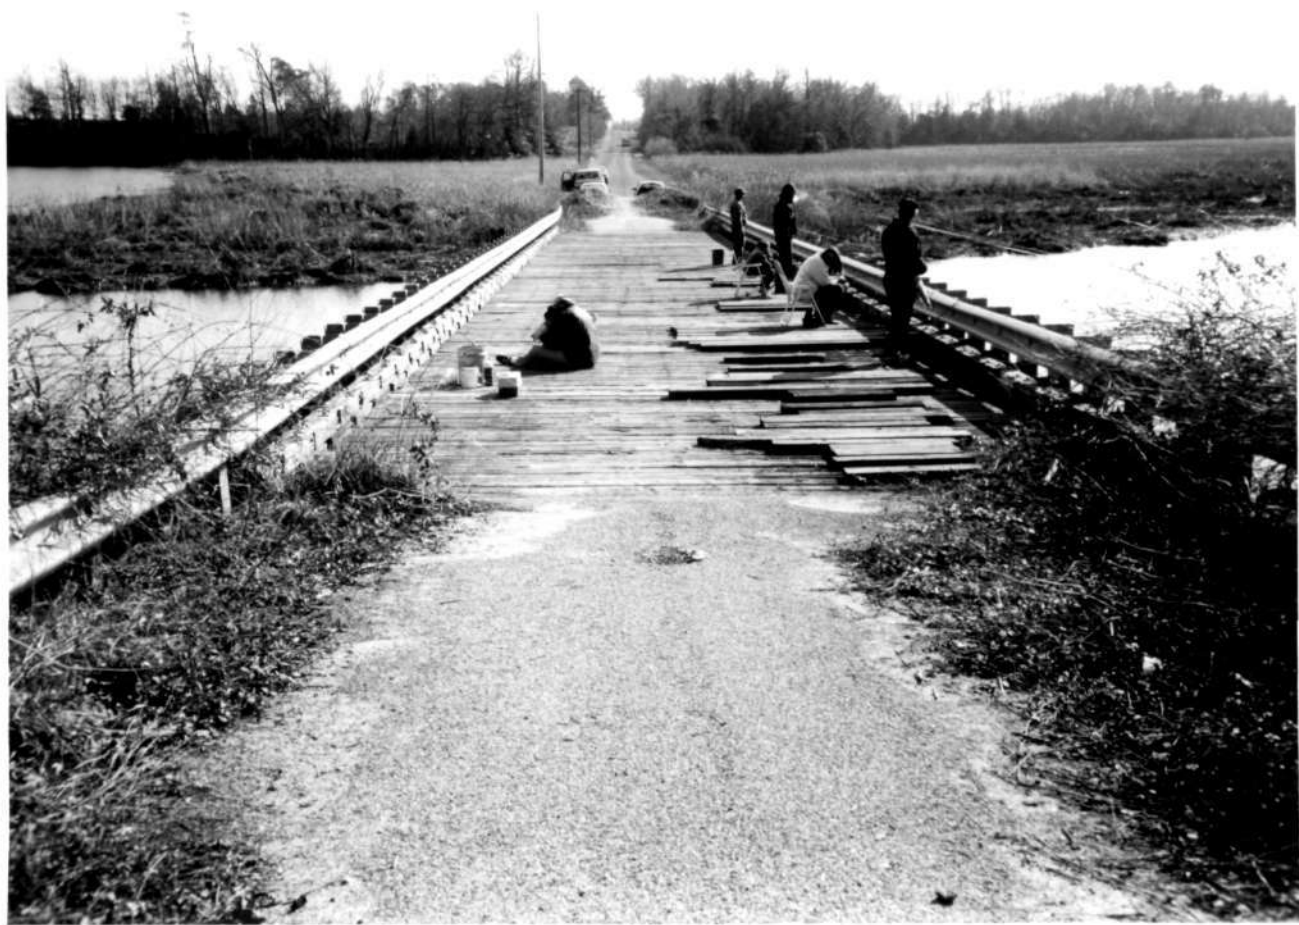
- 1 D-709
- 2 Back Landing over Hunting Creek
- 3 Dorchester Co., MD
- 4 3/98
- 5 Marris German, Luma
- 6 MD SHPO
- 7 Looking South
- 8 4 of 4
